# Manhole Inspection Summary

Manhole # S39CC1021MH

Insp Date: **12/12/06 9:28 AM**

**Location** Address: **749 37TH**

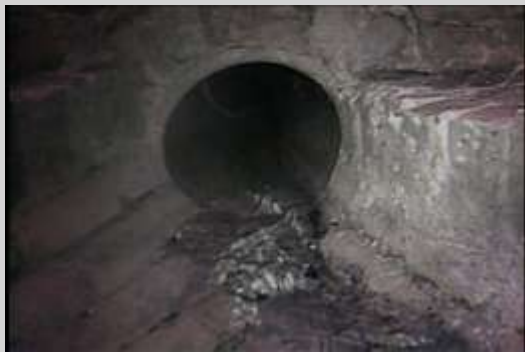
### 8 in. Circular Gravity Sewer Pipe Out @ 12 O'Clock

Pipe Material: **Clay** ☐ Pipe Lined

Invert Depth: **6.69** (ft.) Flow Characteristics: **Slow**

Infiltration: **None** Pipe Seal Cond: **Unknown**

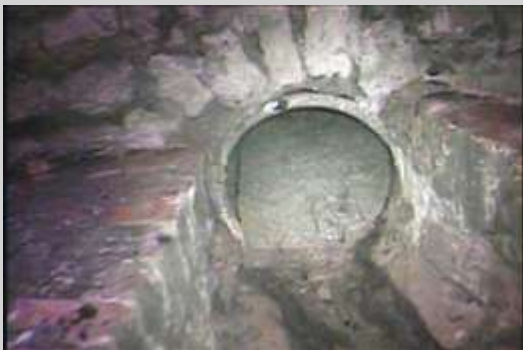
### 8 in. Circular Gravity Sewer

Pipe Material: **Clay** ☐ Pipe Lined

Infiltration: **None** Pipe Seal Cond: **Unknown**
